**Hydrographic Survey Associated With The Miss Megan Accident  
West Cote Blanche Bay  
St. Mary Parish, Louisiana**

**CHEVRON USA  
5750 Johnston Street  
Lafayette, Louisiana 70503**

**John Chance Land Surveys, Inc.  
200 Dulles Drive  
Lafayette, Louisiana 70506**

**Project Number 06-0654**

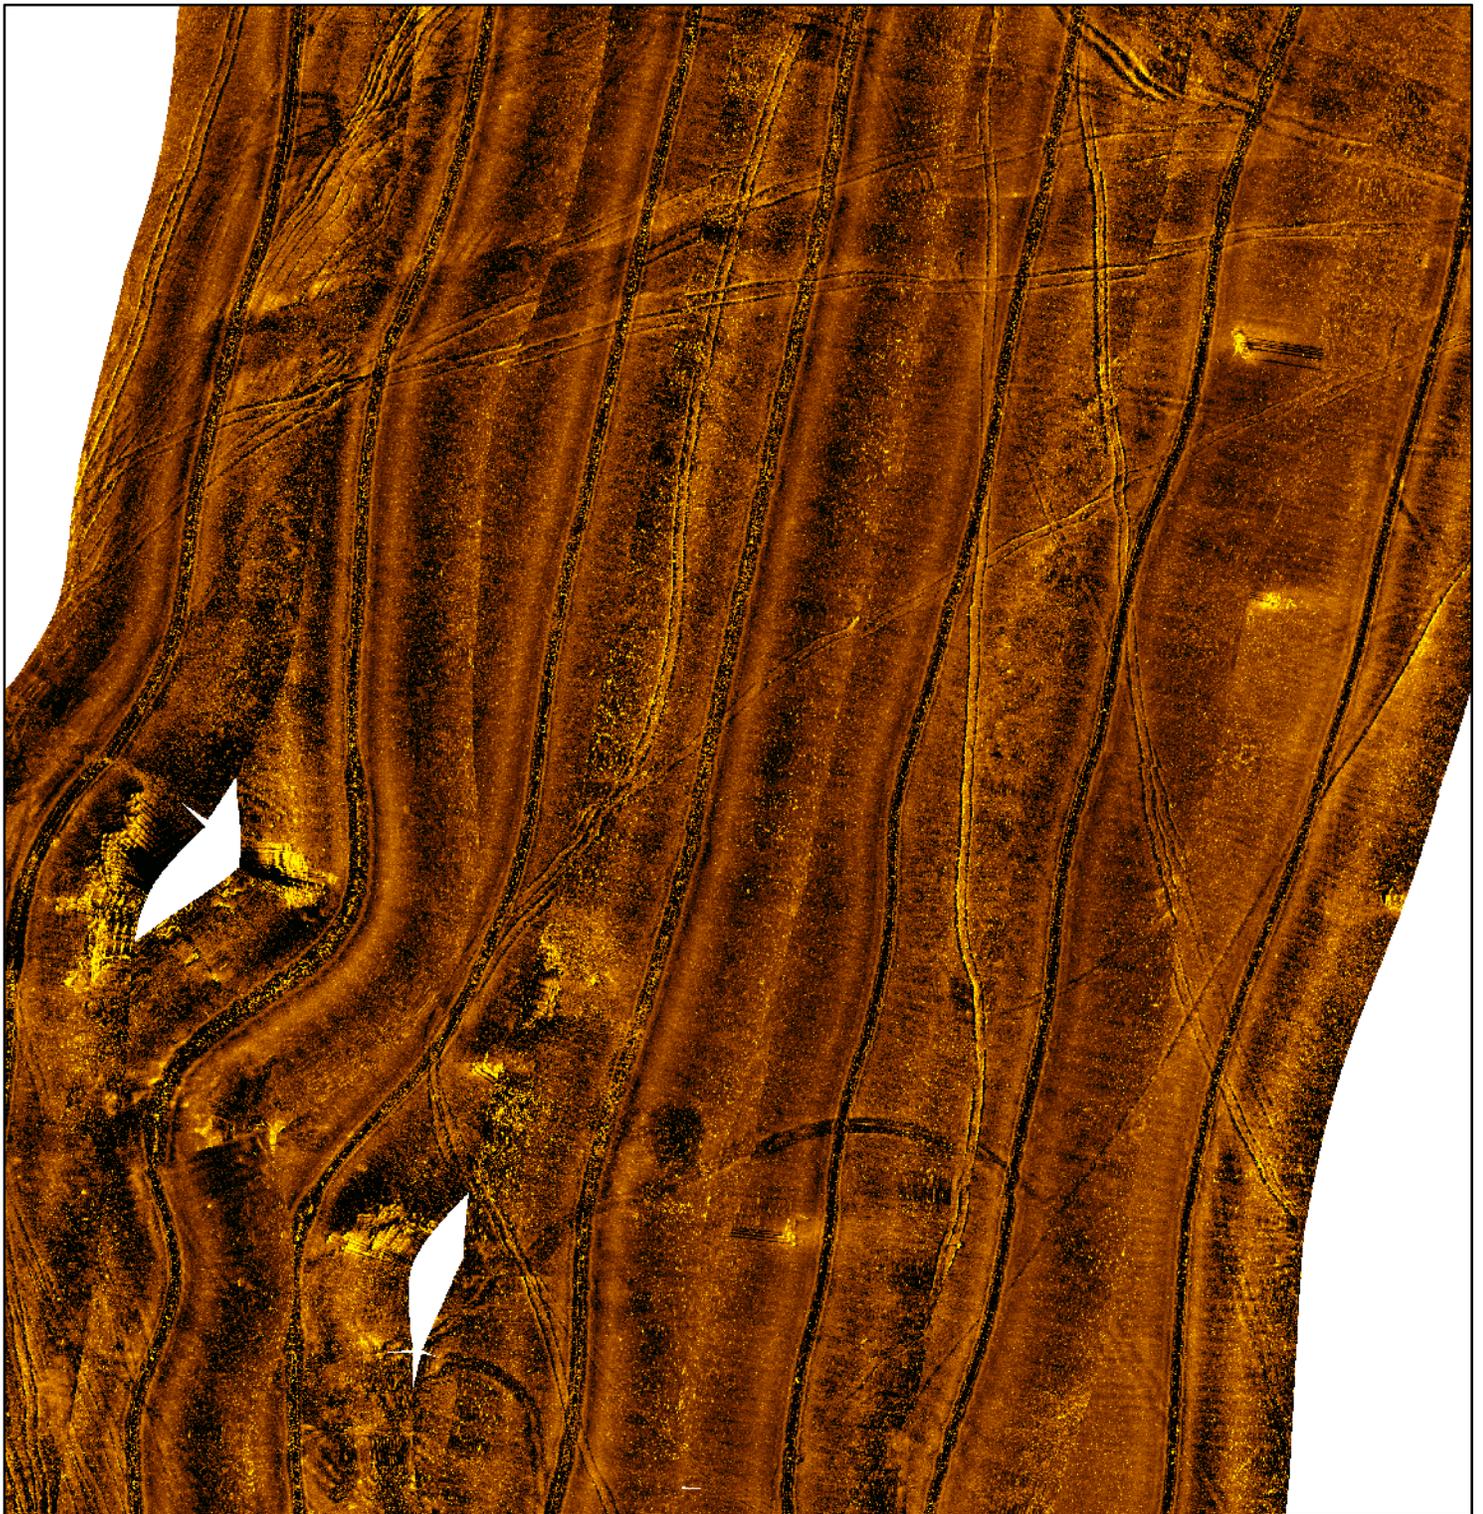
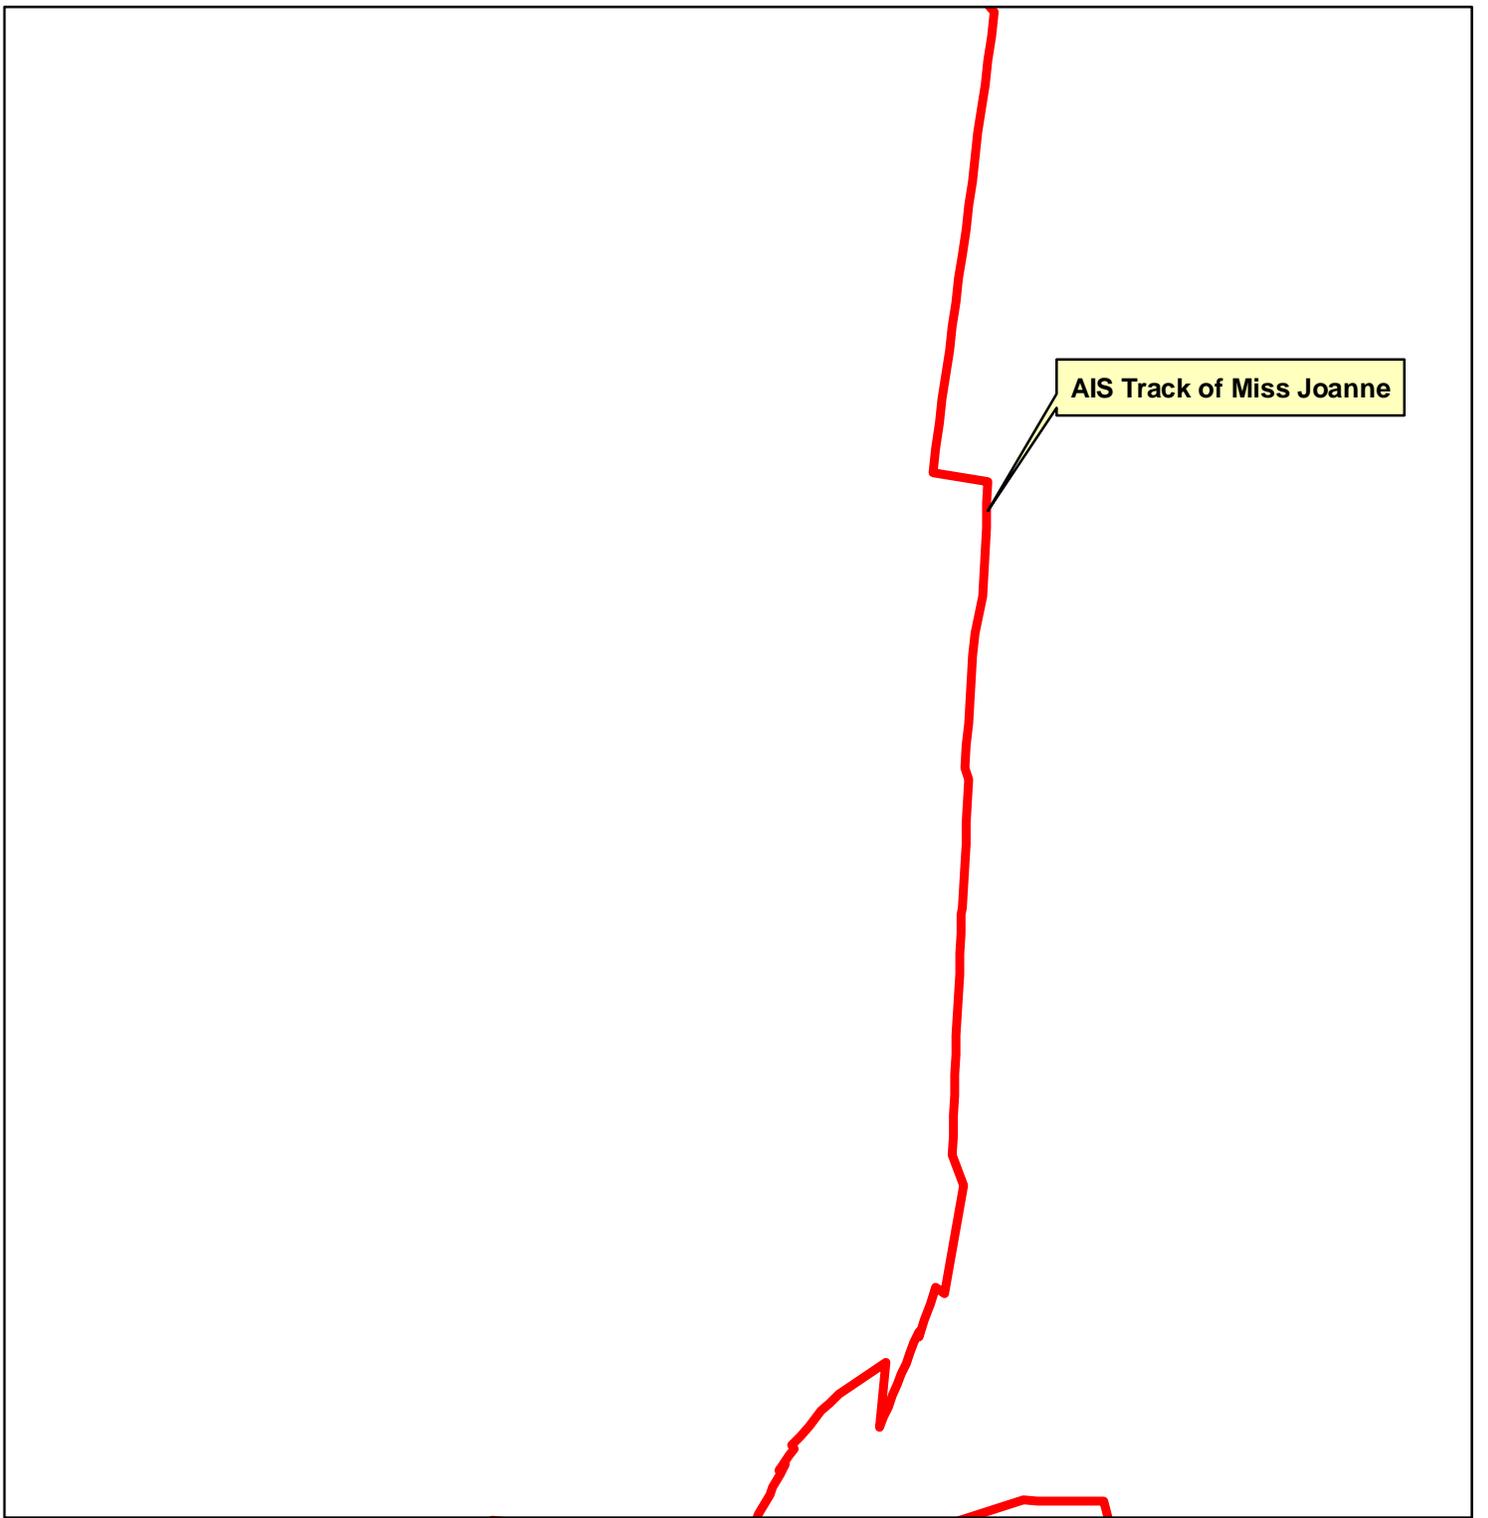
**Figure 7 AIS Validation**

In order to determine the validity of the AIS tracking data that was given to JCLS, a comparison between propeller scarring and the AIS tracking data was made. The MISS JOANNE AIS track was overlaid onto the side-scan sonar imagery as shown in Figure 7. Within the imagery there is propeller scarring that matches that of the MISS JOANNE AIS tracking data and therefore concludes that the pairing of propeller scarring and AIS tracking data is valid.

FIGURE 7 - Detail of AIS Validation  
West Cote Blanche Bay  
St. Mary Parish, Louisiana

AIS Track of Miss Joanne
